Maintenance Actions to Address Fatigue Cracking in Steel Bridge Structures

PROPOSED GUIDELINES AND COMMENTARY

NCHRP Transportation Research Board of
The National Academies

Robert J. Connor and Jason B. Lloyd
Purdue University
West Lafayette, Indiana

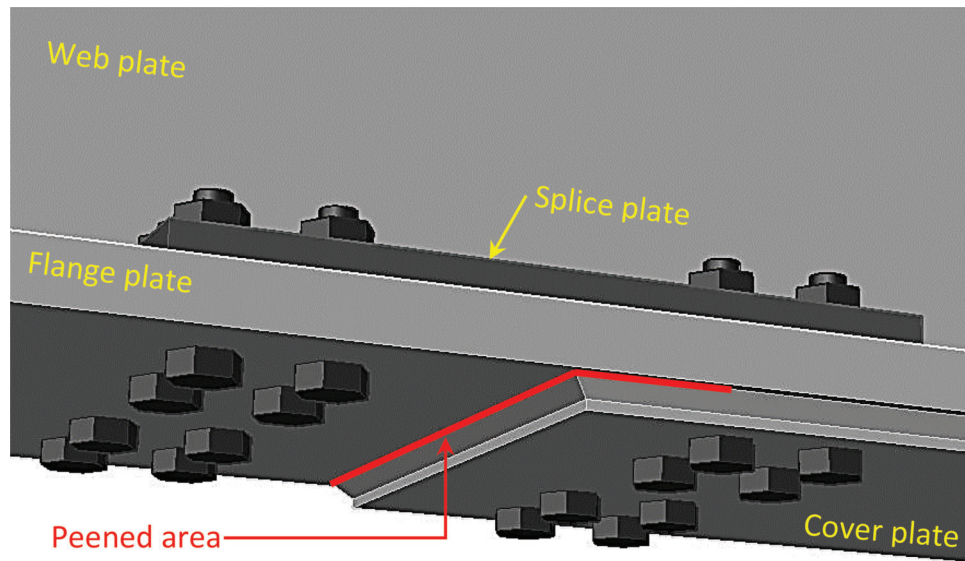
Figure 5.7 Rendering of partial flange splice at a bottom flange cover plate detail with weld toe peening.

the bridge is a concern, an alternative “partial bolted splice” proposed by Hassan and Bowman (1995) could be implemented with reliable fatigue enhancement subtracting only the height of the bolt head from the existing clearance. This retrofit involves the use of a bolted splice plate connection above the flange (bottom splice plate is omitted) and post-weld peening treatment of the cover plate end welds. The improved fatigue life is gained by peening the weld toe, as well as reducing the live load stress range by adding the top splice plate. Figure 5.7 depicts a typical partial bolted flange splice. Fatigue test results for this retrofit showed that it was not as effective as the full bolted flange splice, but will improve fatigue resistance over status quo when under clearance is a limiting parameter. Detailed procedures and example details for these bolted splice repairs and retrofits are provided below.

4. Peen or apply UIT to the weld toes. The area treated should include all transverse welds at the end of the cover plate and at least 2 to 3 inches of weld back from the end of the cover plate (see Figure 5.7). Refer to Section 4.5.3 and Section 4.5.5 for peening techniques.

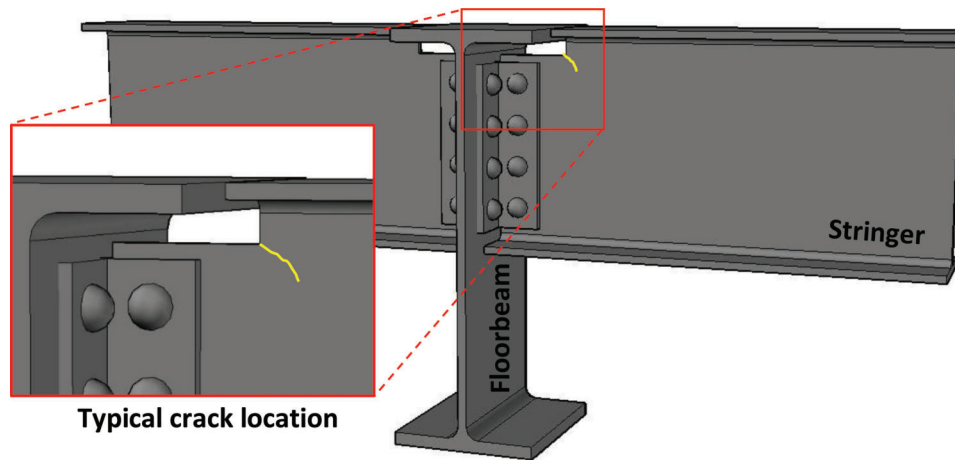
Figure 5.8 Sample re-entrant corner details with no transition radius.

Coped and blocked stringers and floorbeams have been commonly used to frame members together on steel bridges for decades. A typical design detail is shown in Figure 5.8. Variations of this detail have been used in

railroad and highway applications, alike. The typical location for cracking has also been highlighted.

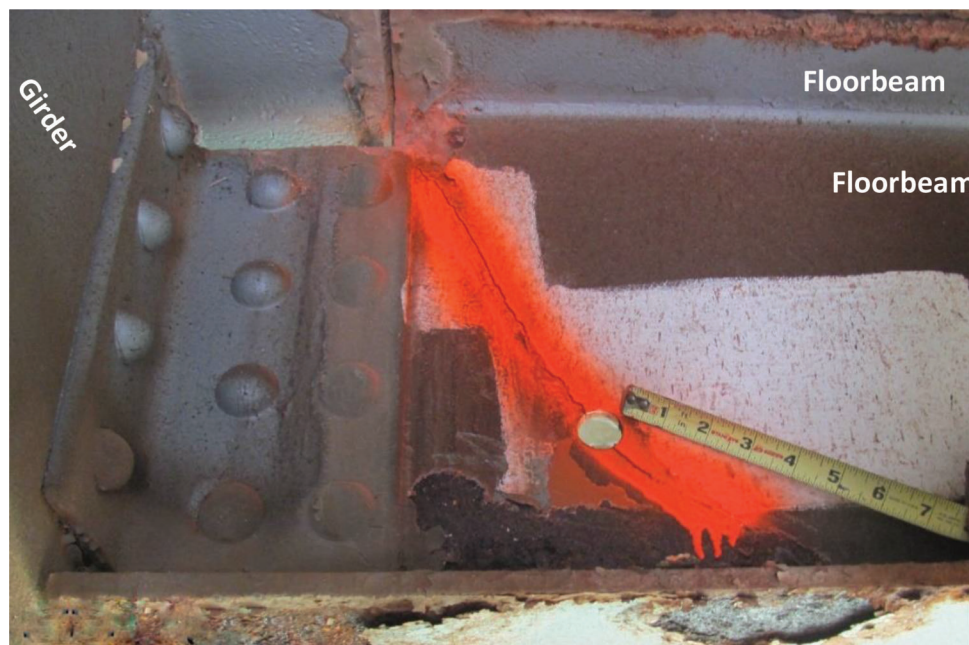
Figure 5.9 Example of load-induced crack at floorbeam cope (Photograph courtesy of Oklahoma DOT).

to produce large cyclic stresses in the coped section of the member. Metallurgical changes resulting in a hard layer of martensite with micro-flaws and residual tensile stresses approaching the material yield strength resulting from the thermal-cut edge can promote fatigue crack nucleation (Yam & Cheng, 1990). Furthermore, because of the residual tensile stresses at the burned edge, cracks can be initiated under cyclic compression and continue to propagate due to the principal stress that results from the end shear (Fisher, 1984; Yam & Cheng, 1990). An example of floorbeam cope fatigue cracking is illustrated in Figure 5.9 where the crack almost propagated completely through the cross section. Another example is seen in Figure 5.10.

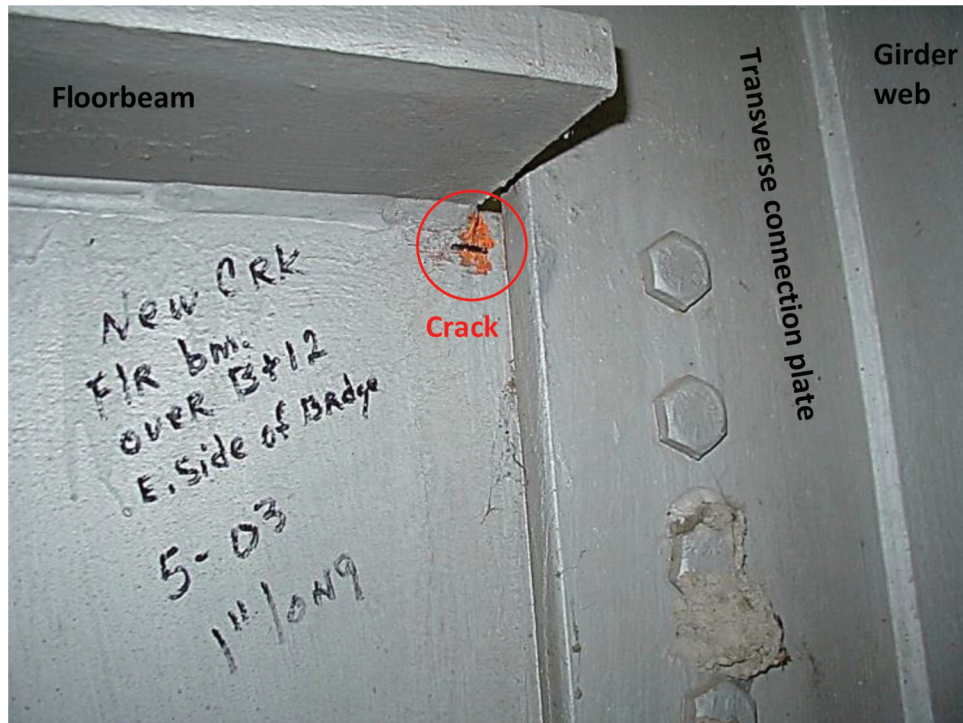
Figure 5.10 Example of floorbeam cope crack (Photograph courtesy of Kansas DOT).

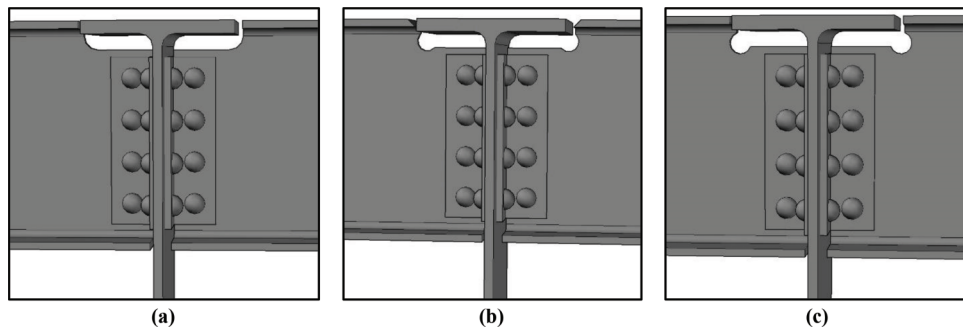
Figure 5.11 Examples of typical acceptable copes.

4. Use a thermal cutting process, such as plasma arc or oxygen cutting, etc., to make any straight cuts necessary. In some cases, this step may not be required, leaving an acceptable retrofit detail that is similar to Figure 5.11(c).
5. Follow the guidelines provided for surface grinding in Section 4.4. Grind the entire length of any thermally cut edge (after cooled) removing approximately 1/16 inch of material while maintaining smooth and gradual transitions.
6. Perform MT or PT after grinding to check for remaining flaws. If a flaw is located, continue grinding to remove the flaw while maintaining a smooth cope profile.
7. Paint the repair area using recommendations provided in Section 4.2.
8. Follow up with typical visual inspections scheduled with the regular inspection cycle for the bridge.

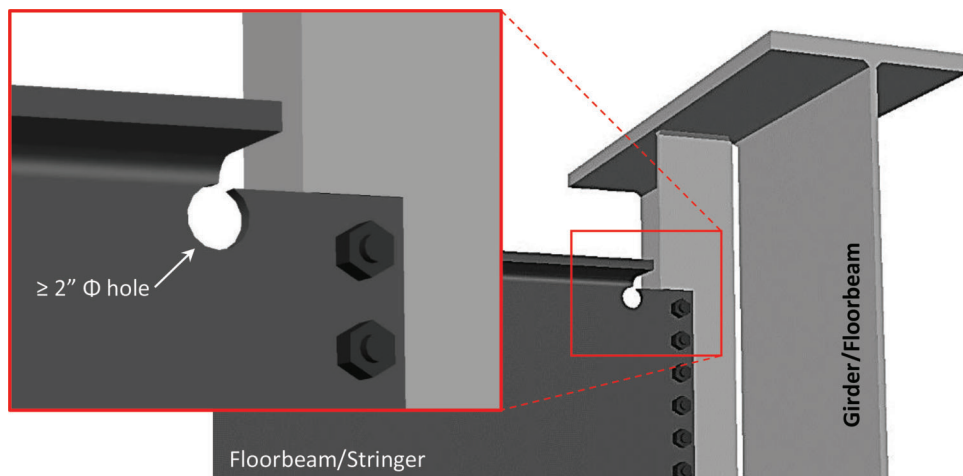
Figure 5.12 Drilled hole used to increase cope transition and reduce stress concentration.

The following steps outline the proper procedure for increasing the transition radius to retrofit re-entrant corners at floorbeams and stringer copes. Reference Figure 5.12 for further details.

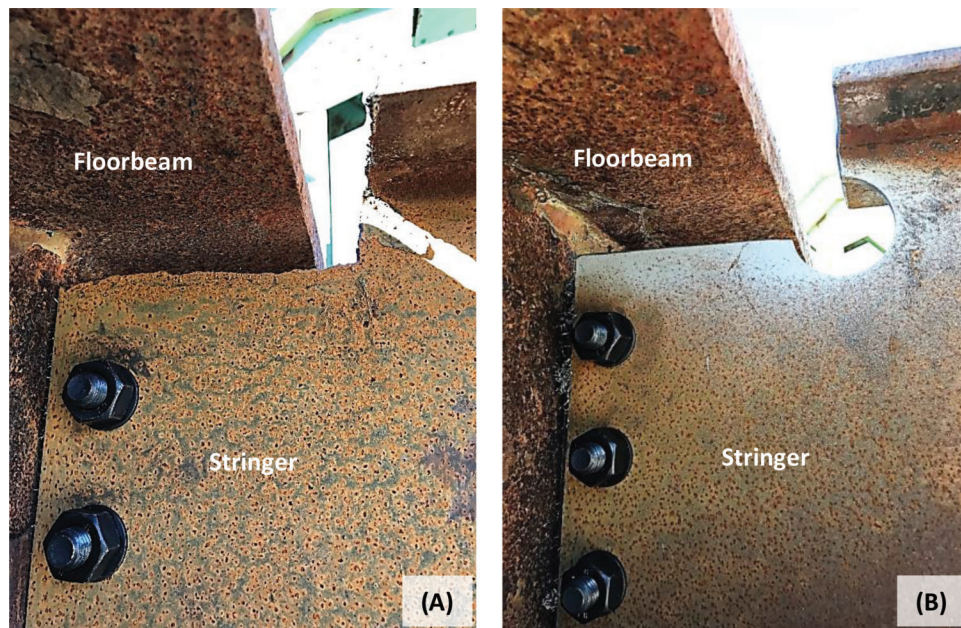
Figure 5.13 Before (A) and after (B) pictures of cope transition retrofit.

Figure 5.13 shows an example of a properly retrofit cope detail with before and after views. Notice in photograph (B) the drilled hole and the former cope discontinuity that improves stress flow into the bolted connection. Also, the flame cut edges have been ground smooth, removing flaws and brittle material.

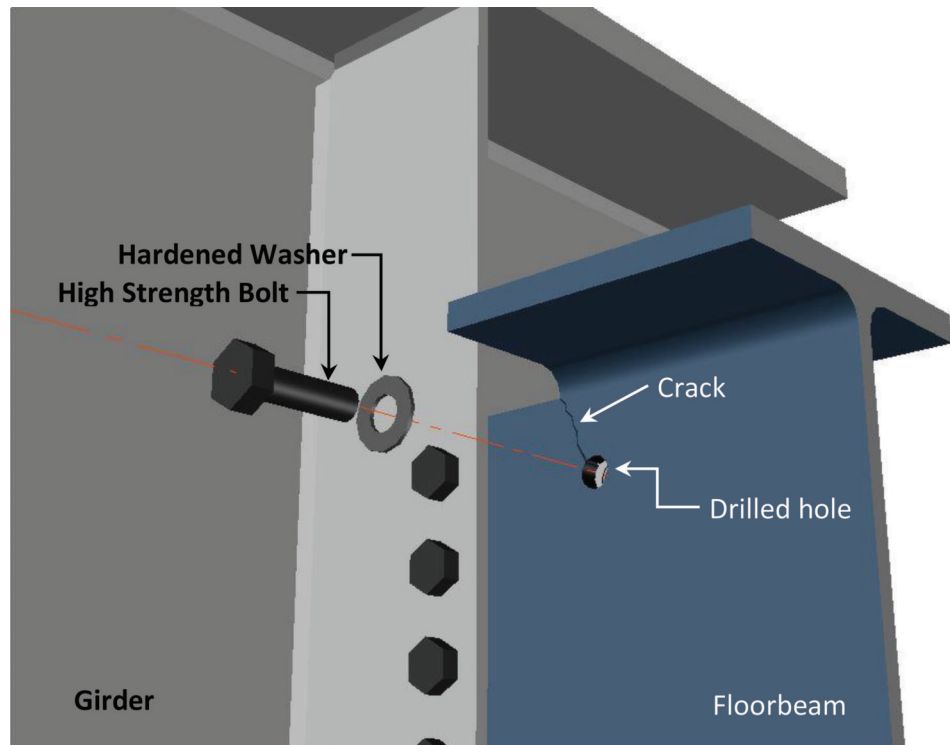
Figure 5.14 Drilled hole retrofit for cracked cope details using high strength bolt assembly.

The following steps outline the proper procedure for repair of cracked re-entrant corners at floorbeams and stringer copes using drilled holes. Reference Figure 5.14 for further details.

3. *Recommended:* For improved fatigue resistance, install F3125 Grade 325 or 490 high strength bolts using turn-of-nut or other approved method according to current RCSC specifications. Install the bolts with F436 hardened washers on both sides of the drilled plate. The bolt assembly detail is shown in exploded view in Figure 5.14.

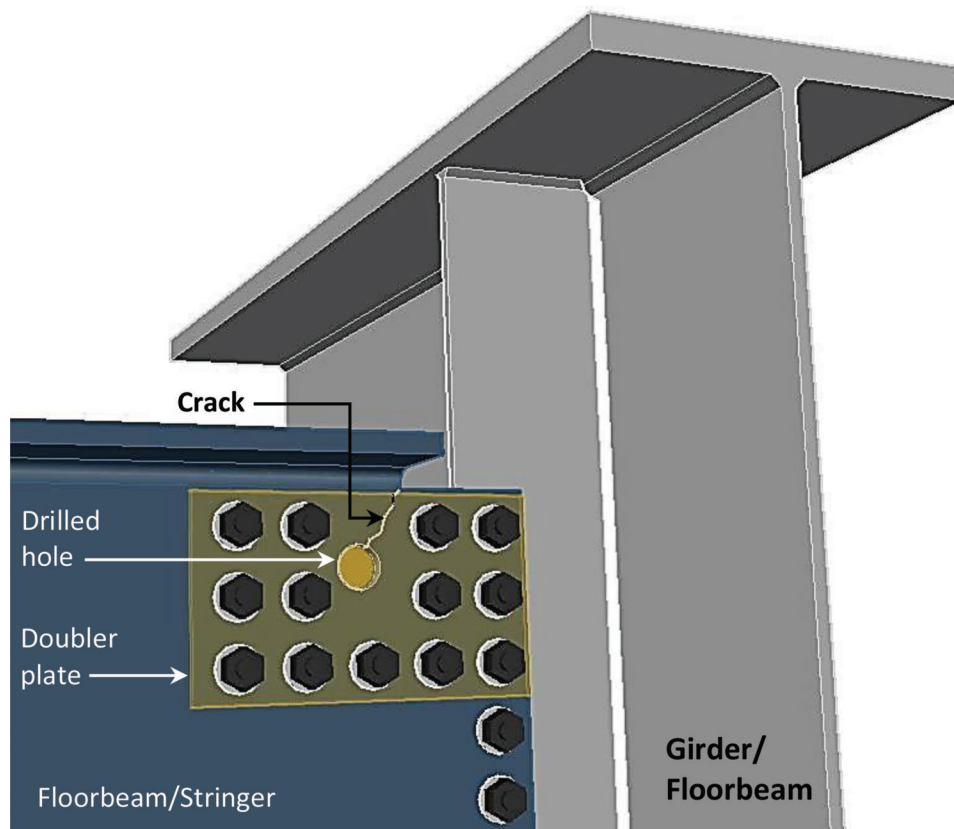
Figure 5.15 Bolted doubler plate retrofit with drilled hole for crack arrest.

The following steps outline the proper procedure for repair of cracked re-entrant corners at floorbeams and stringer copes using a bolted doubler plate detail. Before installation can begin, a qualified engineer should design the doubler plate detail. Figure 5.15 illustrates a typical design where two doubler plates, each equal in thickness to the original floorbeam or stringer web, are installed. When possible, extend the doubler plates onto the connection plates, as shown, and replace the fasteners with F3125 high-strength bolts. The doubler plate has been rendered semi-transparent in Figure 5.15 to reveal the crack and drilled hole behind it.

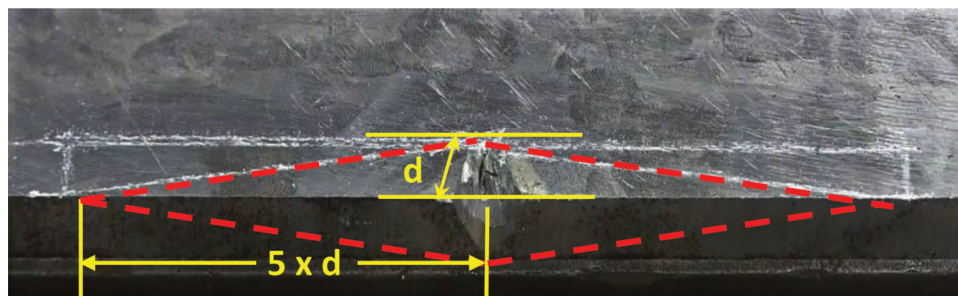
Figure 5.16 Example of 5:1 taper ratio markings.

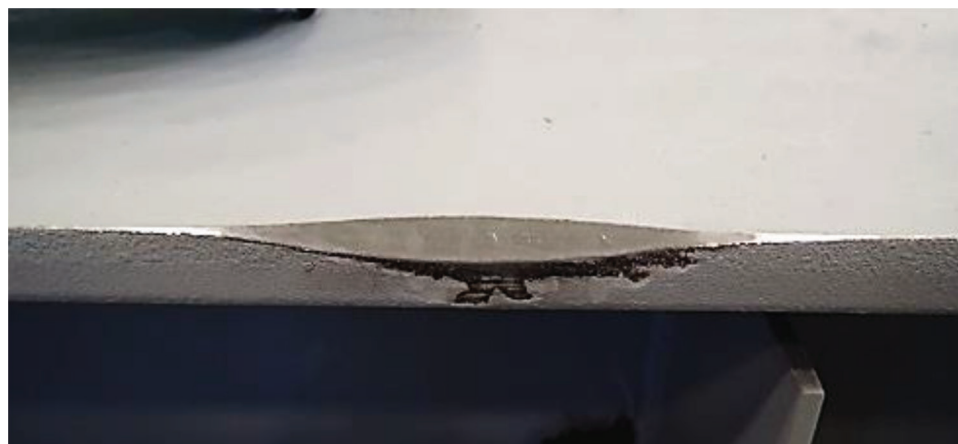
Figure 5.17 Example of edge flaw removed with 5:1 fairing ratio.

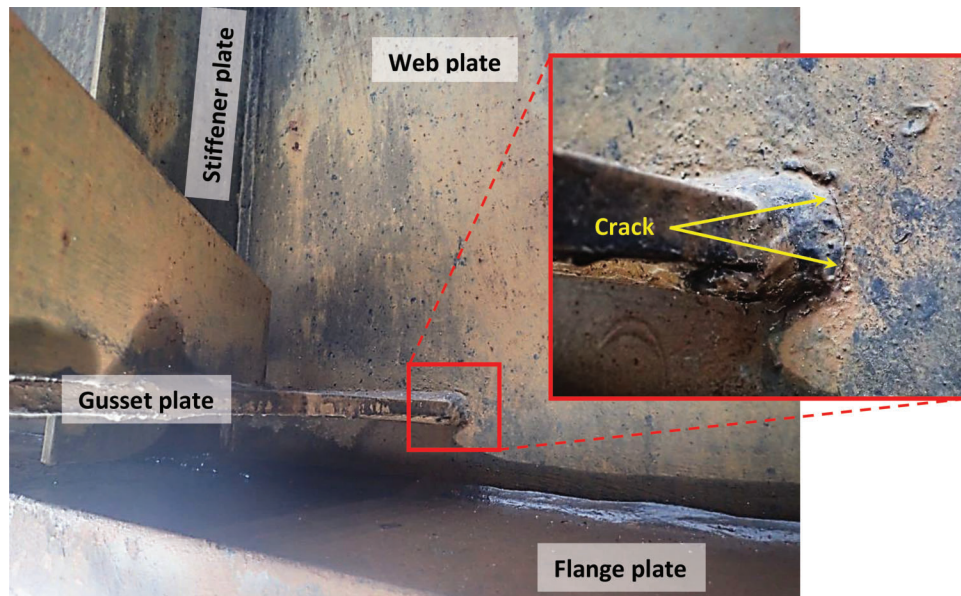
Figure 5.18 Example of fatigue crack at gusset plate weld termination.

Cracks have been discovered initiating in the weld toes at the ends of the welds propagating vertically up and down the web plate. Figure 5.18 shows an example of this type of crack at a gusset plate and Figure 5.19 shows a fatigue crack at the end of a longitudinal stiffener. Sometimes the welds are wrapped around the end of the plate like shown in Figure 5.18, but sometimes there is a gap between the weld ends like seen in Figure 5.19. Both conditions result in the same fatigue resistance.

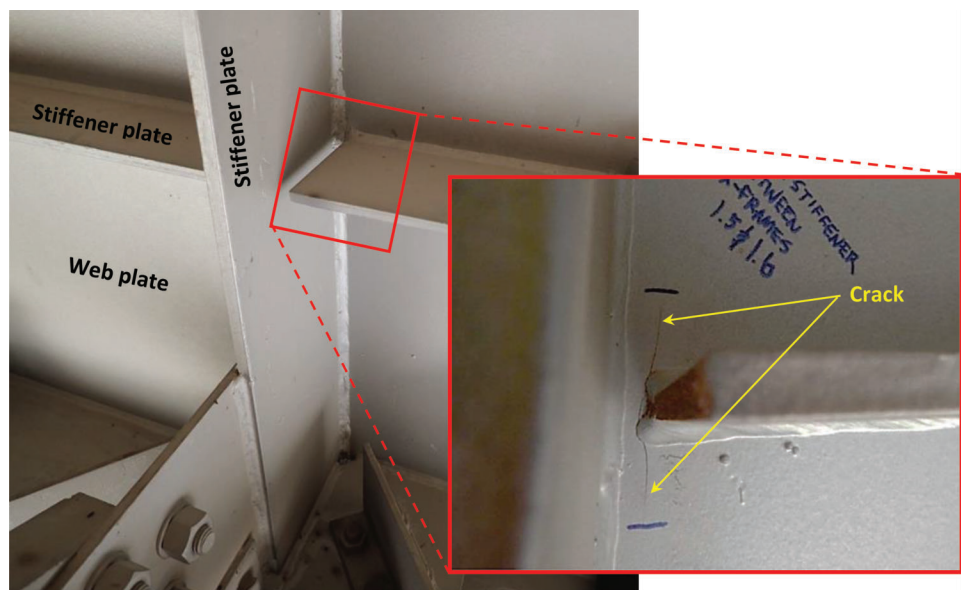
Figure 5.19 Example of fatigue crack at longitudinal stiffener weld termination.

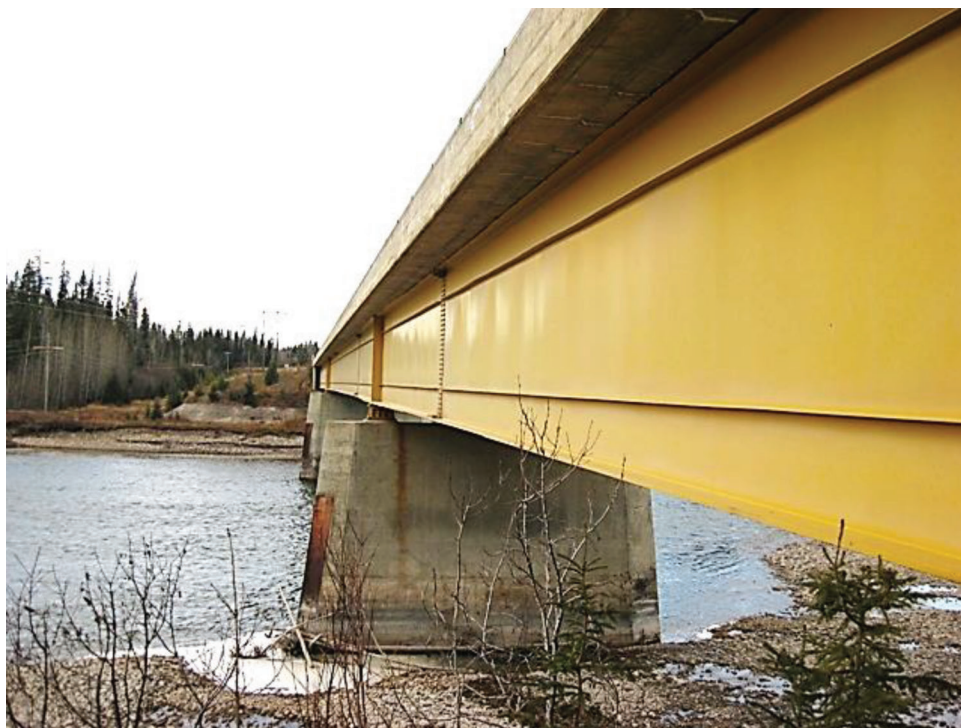
Figure 5.20 Example of longitudinal stiffeners located in tension and compression zones.

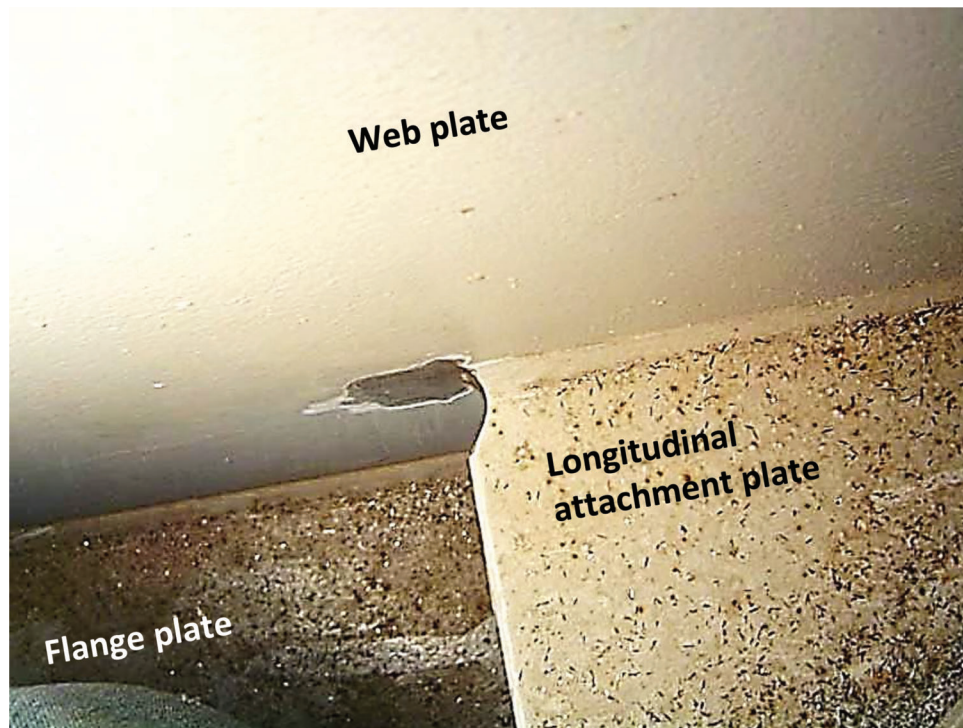
Figure 5.21 Weld termination removal using burr bit and die grinder (Photograph courtesy of Iowa DOT).

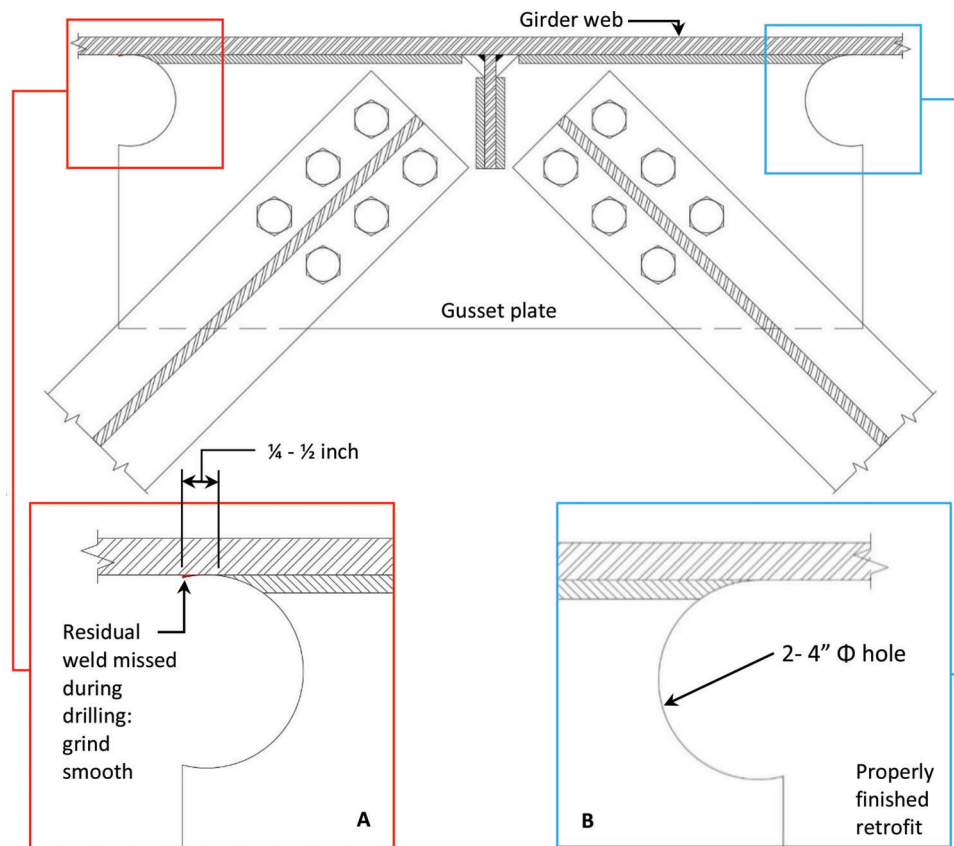
Figure 5.22 Retrofit for plate termination using drill and annular cutter.

Option: Remove the bulk of the material and weld from the plate using a mag-based drill. Align the annular cutter such that it is flush with the web plate at a point approximately 1/4 inch to 1/2 inch back from the end of the weld. This will result in a partial circle cut at the edge of the gusset or longitudinal stiffener plate with some weld remaining attached to the web. Grind off the residual weld flush with the web plate. Figure 5.22A shows what a typical plate termination will look like after drilling a 4 inch diameter hole. Notice the small weld material that was missed by the drilling, which needs to be ground smooth in Figure 5.22A. Figure 5.22B shows the retrofit as it should be completed, with the weld ground smooth to the web. Although Figure 5.22 is drawn for a gusset plate termination, the same detail can be used on a longitudinal stiffener plate termination.

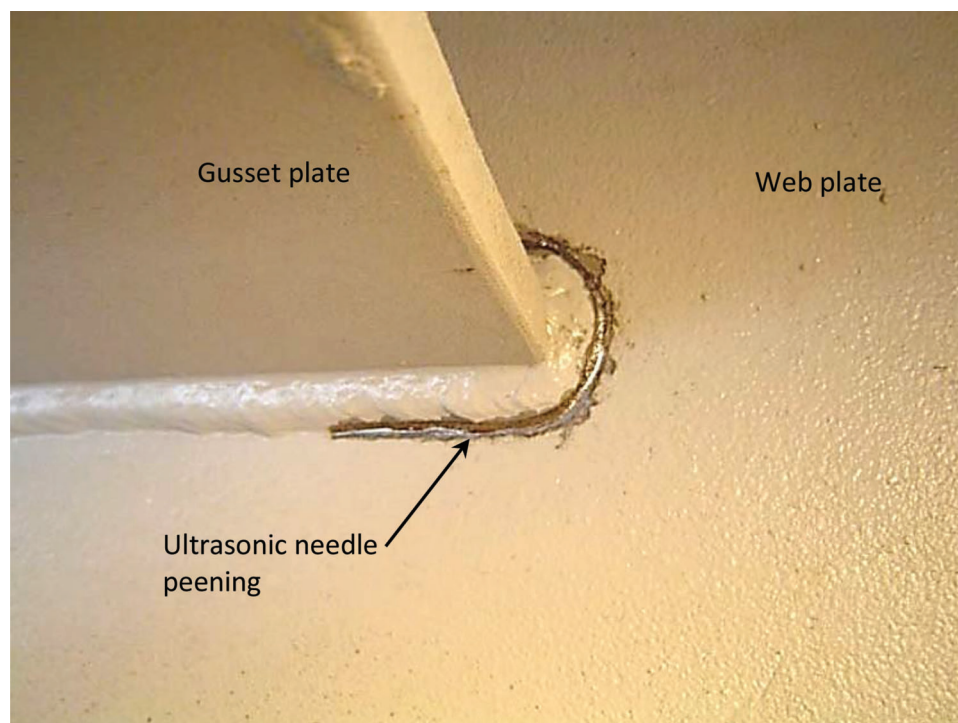
Figure 5.23 Weld toe peening at gusset plate termination (Photograph courtesy of Iowa DOT).

5.4.2.2 Weld Toe Treatment. Weld toe treatment is described in detail in Section 4.5 of this guideline. Refer to this section for a complete description of weld toe grinding for removing existing cracks, as necessary, and to apply post weld peening treatment. Peening should be applied to the last 2 to 3 inches of the gusset or longitudinal stiffener plate weld, following the weld toe in contact with the web plate. If the weld wraps around the end, ensure that the peening treatment follows the weld toe around and continues for 2 to 3 inches along the underside of the plate, as seen in Figure 5.23. It is not clear from this figure whether or not the paint coating was removed prior to peening. This is an important step to ensure quality peening treatment. Tool access between the attachment plate and adjacent flange plate should also be considered before choosing this retrofit approach.

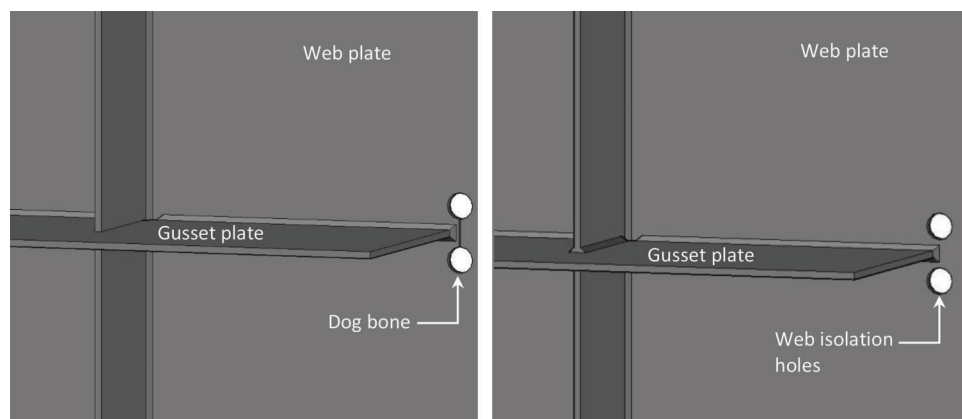
Figure 5.24 Example of dog-bone retrofit (left) and web isolation holes (right).

Two to 4 inch diameter drilled holes are recommended. Larger holes improve fatigue resistance by further reducing stress concentration at the edge of the holes. Figure 5.24 shows an example of the dog-bone retrofit on the left and the web isolation holes retrofit on the right.

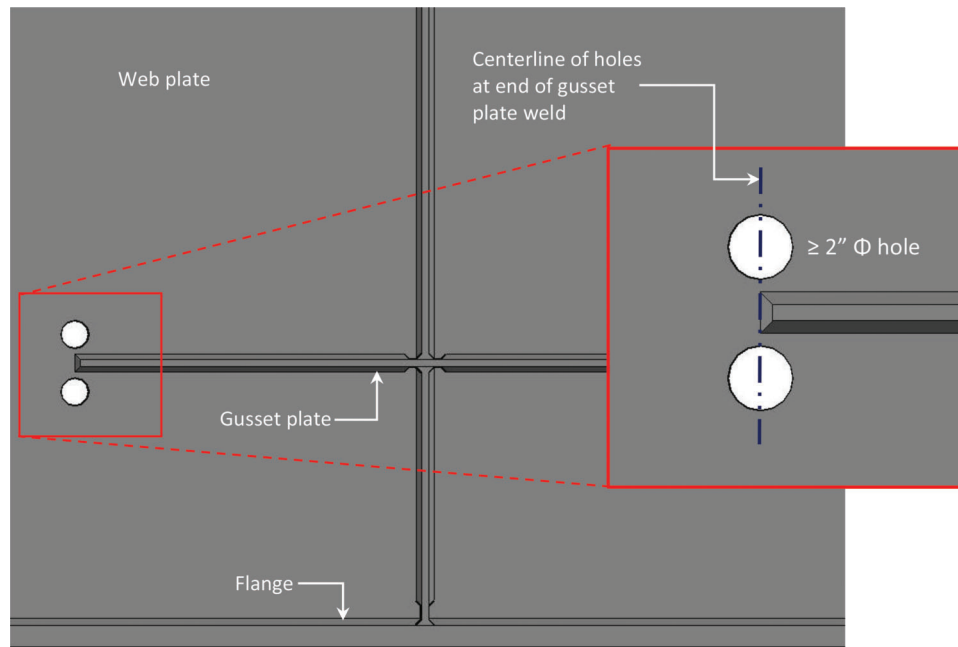
Figure 5.25 Example of web isolation hole placement at weld termination of a gusset plate.

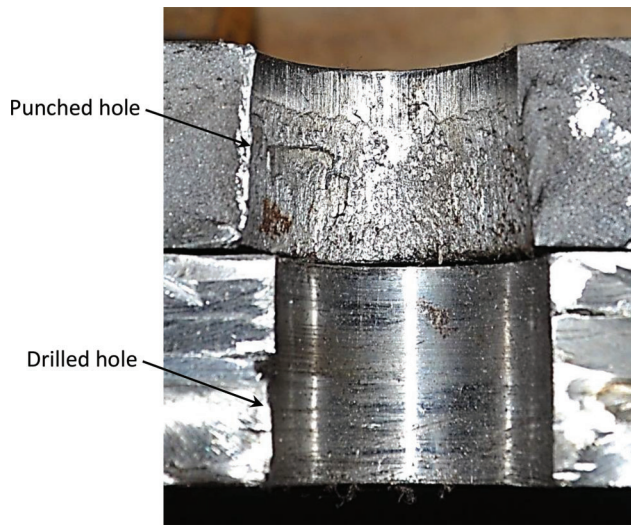
Figure 5.26 Example of punched and drilled hole quality.

Figure 5.26 shows a punched hole and a drilled hole side-by-side. Notice that the punched hole has shear lap defects where it appears as if the material was smeared. Drilled holes will not always appear as smooth as Figure 5.26 appears, this will be a product of the drilling rate and bit sharpness. Another look at a drilled hole is shown in Figure 5.27(a) where it reveals the drilling striations. Figure 5.27(b) also shows a similar perspective for a punched hole. This is the view that a worker would have in the field when trying to determine whether the holes are punched or drilled.

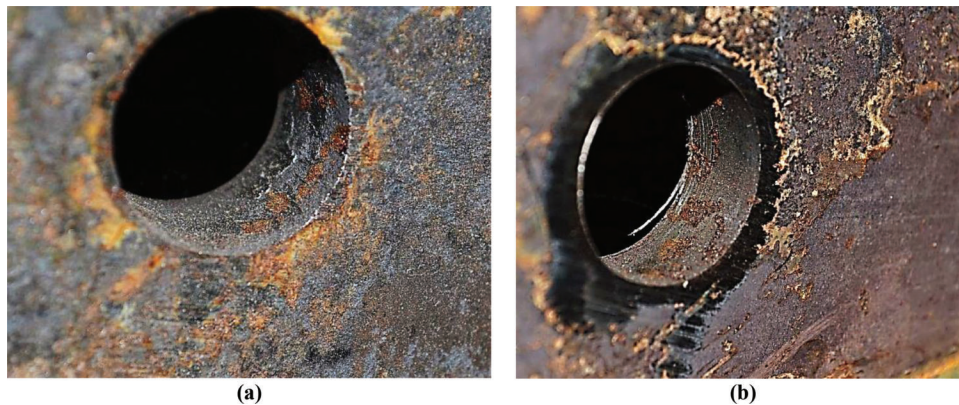
Figure 5.27 Perspective with rivet removed revealing appearance of punched (a) vs. drilled (b) hole.

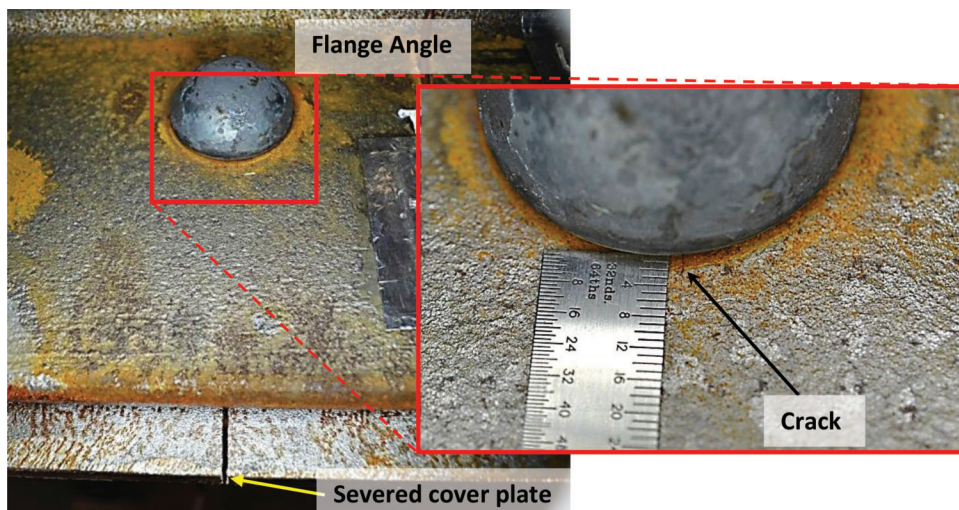
Figure 5.28 Test specimen showing fractured cover plate with fatigue crack propagating from rivet hole in the flange angle (Hebdon, 2015).

Hebdon (2015) took this a step further by determining the fatigue resistance of riveted built-up full scale girders after a single component (i.e., cover plate or flange angle) was completely failed (either due to fatigue or fracture). An example of these test specimens is shown in Figure 5.28 where it shows the severed cover plate and a fatigue crack propagating out from underneath the rivet head. Results from this research indicated that the AASHTO Category D was a reasonable lower bound for girders with drilled holes, based on an amplified net-section stress range that incorporates localized stress redistribution.

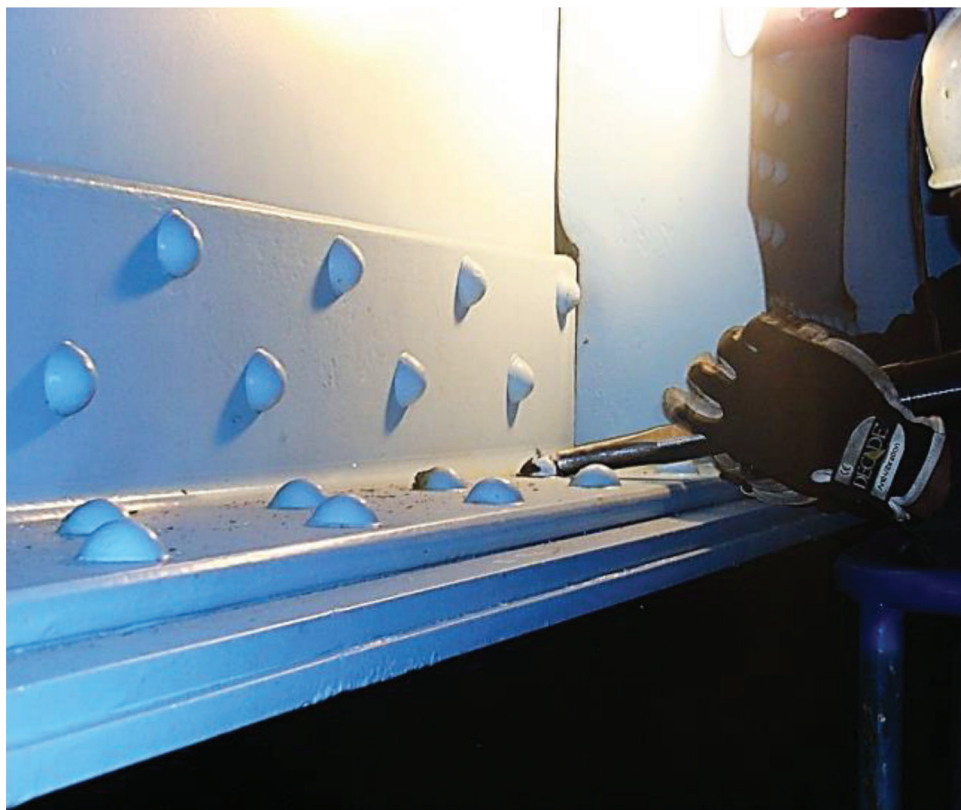
Figure 5.29 Rivet removal using blunt tip and pneumatic rivet buster hammer.

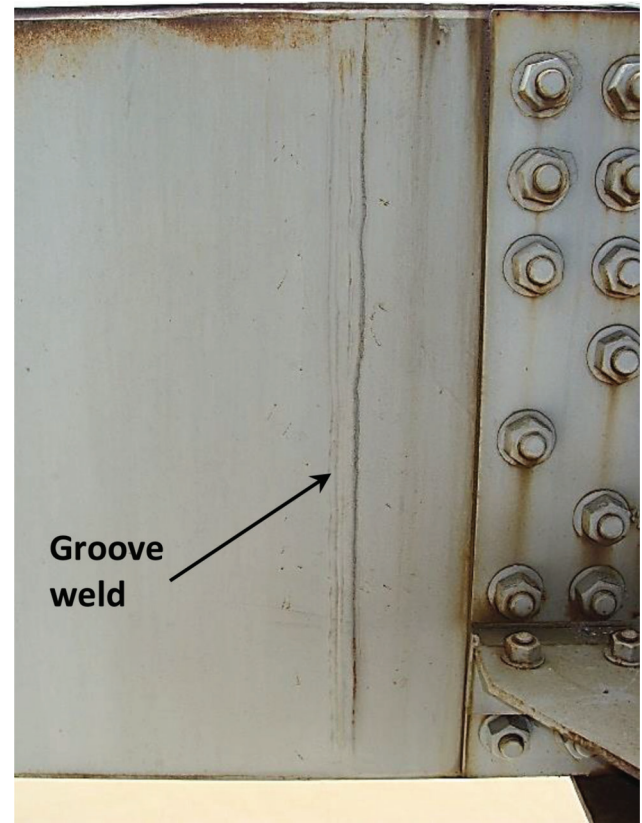
Figure 5.30 Transverse groove weld with reinforcement left in place (Category C).

If the weld reinforcement is left in place, such as that shown in Figure 5.30, the fatigue resistance is reduced by the additional stress concentration at the weld toes. Thus, transverse groove welds with the reinforcement not removed, with or without the correct thickness or width transition slope, are AASHTO Category C. This is relatively good fatigue resistance, and it is not often that a crack will develop at Category C fatigue details on typical highway bridges. However, cracks have been found propagating out of this type of detail, particularly

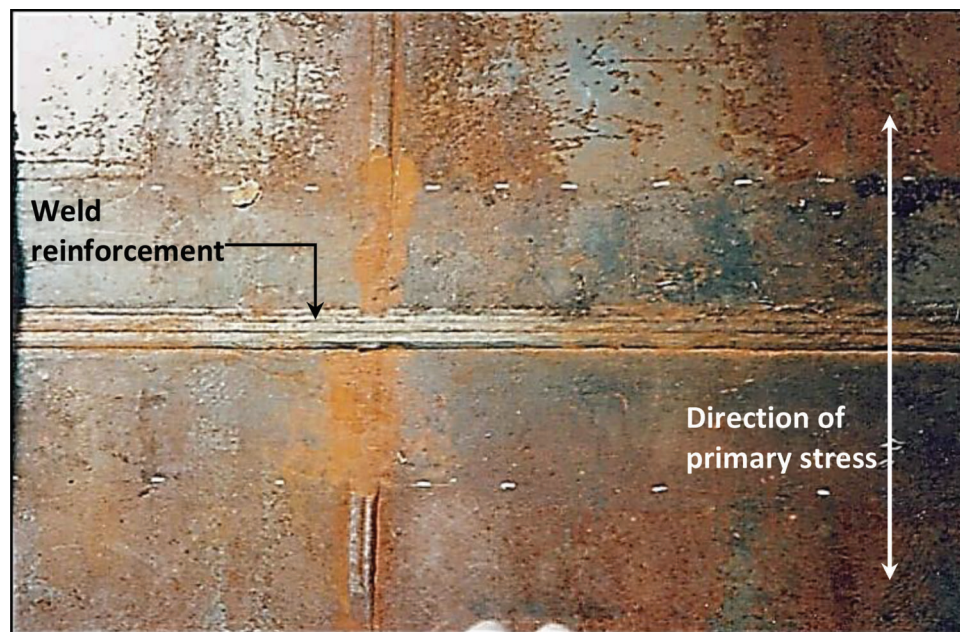
Figure 5.31 Category C transverse groove weld.

5.6.2.1 Grind Weld Reinforcement Smooth. Once the internal soundness of a transverse groove weld has been determined by NDT, one of the most efficient ways to improve fatigue resistance from Category C to Category B is to grind off the weld reinforcement. Figure 5.31 shows a typical transverse groove weld in a flange plate. The weld reinforcement has been left in place. The weld toe creates a stress concentration that reduces fatigue resistance and is the most likely point of crack initiation. By removing the weld reinforcement, the weld toe is also removed, which reduces stress concentration and improves the fatigue strength of the detail. To perform this retrofit, first establish the soundness of the weld using UT or PAUT. Next, follow surface grinding techniques discussed in Section 4.4 being careful to remove the entire

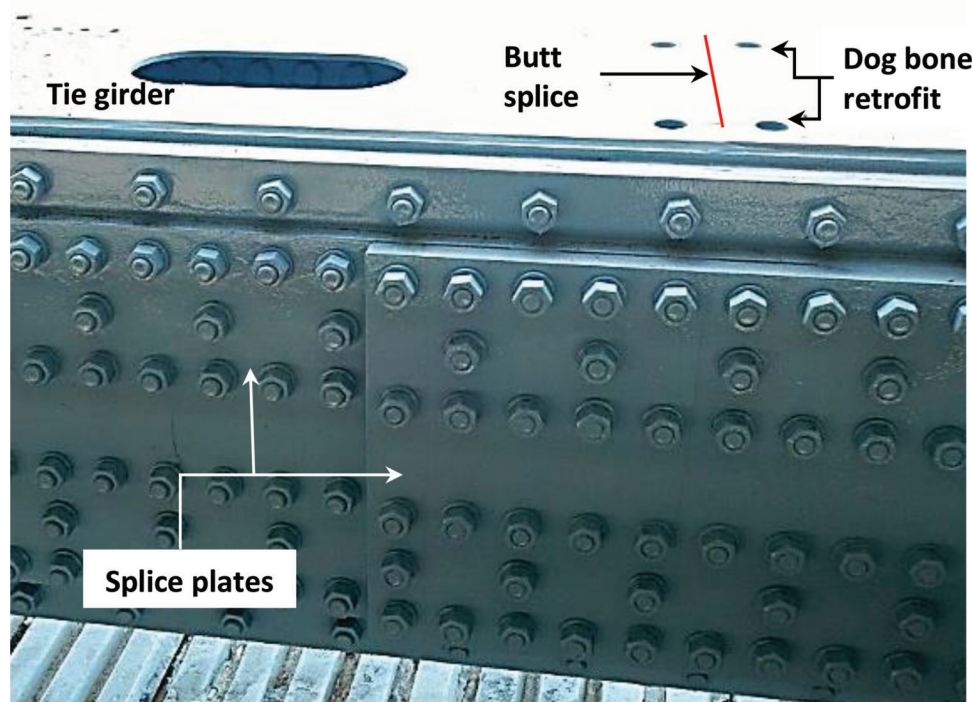
Figure 5.32 Example of bolted splice installed on a tie girder.

of a bolted splice installed on a tie girder on the Sherman-Minton Bridge in Indiana and Kentucky. Note the dog bone retrofit that was also added at the butt splice weld as a safeguard to arrest any unstable crack extension that was deemed possible in a Fitness-for-Service evaluation for the T1 steel. The dog bone retrofit is made up of two drilled holes connected by a cut, as seen better in Figure 5.33. This strategy is typically used for fracture arrest applications and is discussed in further detail in Section 6.6. It is highly recommended to drill a hole at the crack tip of any known cracks, as research has shown that a bolted splice installed after fatigue cracking has initiated may not prevent subsequent crack growth (Hassan & Bowman, 1995).

5.6.2.3 Bolted Splice Retrofit. A slip-critical bolted splice is the most reliable retrofit that can be installed at a transverse groove weld detail. However, it is also the most expensive. For flexural girder applications where cracks are *not* found or where cracks are found to be within the flange plate only, the splice can simply be designed to carry only the flange moment. If an existing fatigue crack has propagated into a girder web plate, then a web plate and flange splice is recommended, sufficiently designed to carry the full moment of the girder at that location. Adding a 2 to 4 inch diameter drilled hole or a dog bone retrofit in the web directly in line with the groove weld could also be done to ensure that any future crack growth cannot extend into the web plate. An example of this is shown in Figure 5.5 showing a fatigue crack that has grown through the thickness of the flange plate and arrested in the drilled hole. For truss or tie girder applications, it is recommended that the splice be designed to carry the entire dead load and live load. Figure 5.32 shows an example

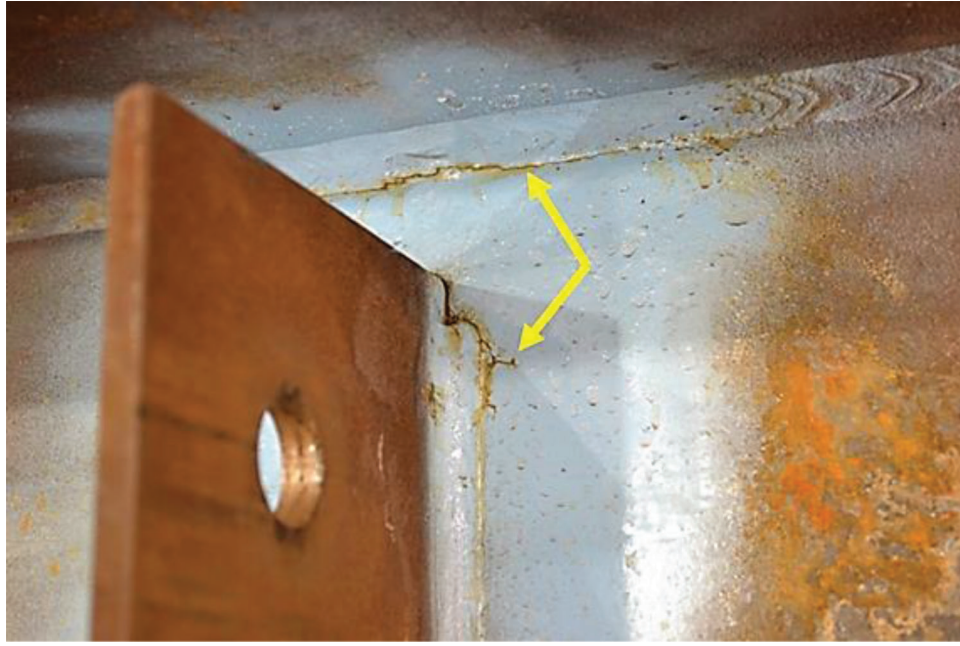
Figure 6.3 Example of web gap cracking resulting from distortion.

image that the cracking has occurred at the transverse weld termination as well as the web-to-flange weld. The dual cracks are common for distortion-induced fatigue due to the reverse curvature of the web plate imposing tensile stresses at the top and bottom of the web gap (which has been illustrated in Figure 6.2, as well).

The driving mechanism for distortion-induced fatigue in the web plate of primary members is illustrated in Figure 6.2. Uneven loading of bridge girders can cause differential vertical deflections. Lateral loads are transferred through the connecting elements into the web plate, which is very flexible out of plane, resulting in web plate reverse bending immediately adjacent to the flange. The inset of Figure 6.2 shows a red portion of the web located in the web gap region between the connection plate and the top flange with a yellow dashed line accenting the web gap distortion. This is the problematic area where cracking can occur. The flange restrains the web plate at the concrete deck similar to the fixed end of a cantilevered beam, generating bending stresses. However, this type of cracking can also occur at the bottom of the connection plate, even in positive moment regions, due to the out-of-plane flexibility of the web plate as compared to the relatively stiff flange plate. Bridges that experience relatively large differential displacements of adjoining members are more prone to this phenomenon, such as skewed bridges, curved bridges, or bridges with large girder spacing. An example of distortion-induced cracking in a girder web gap is shown in Figure 6.3. Note in this

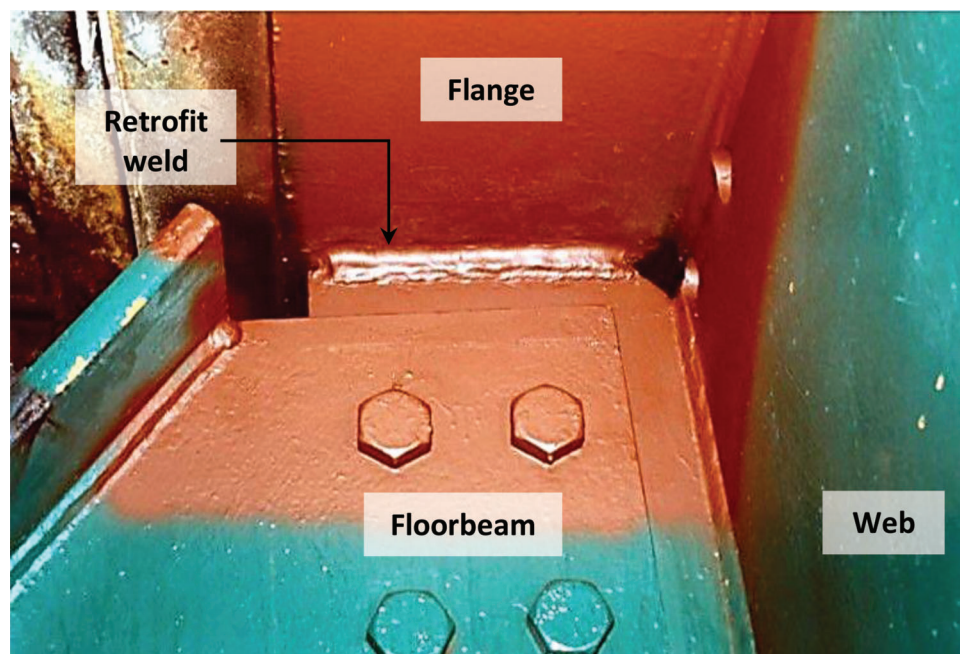
Figure 6.4 Welded splice at connection plate and top flange (Koob *et al.*, 1985).

If the connection plate does not extend close enough to the flange to make the welded splice directly, filler plates can be used to close the gap, stepping up until the gap is sufficiently closed to make the final welds. A number of bridges have been successfully retrofit using this approach (Fisher, 1984). A welded attachment to a flange, however, should be made shorter than 2 inches (parallel with the flange longitudinal axis) in order to achieve Category C fatigue resistance. This

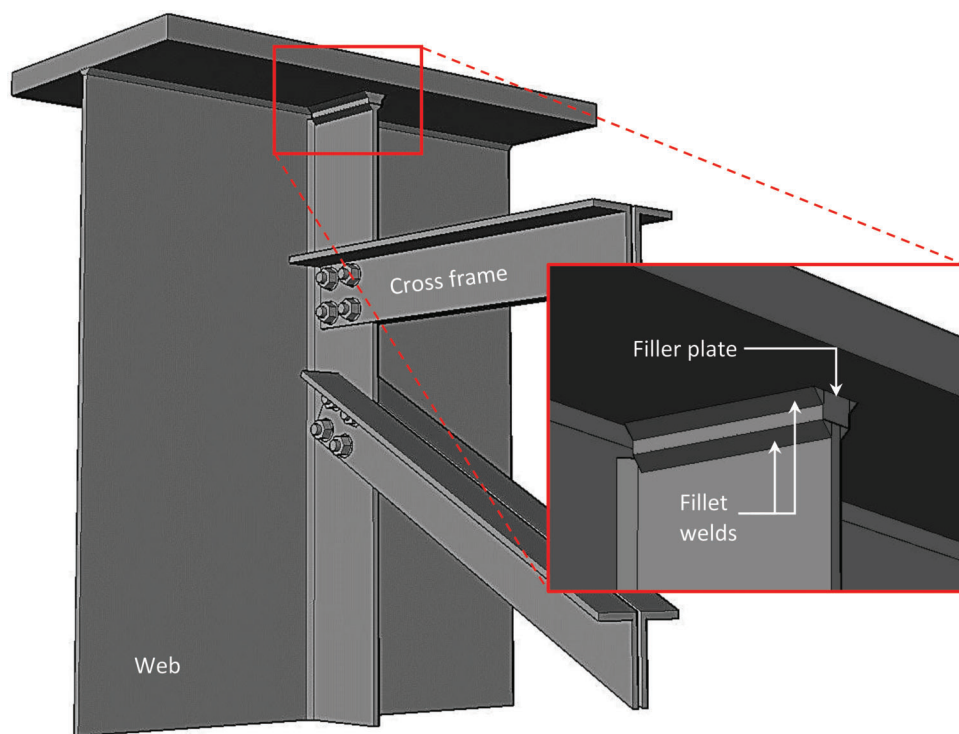
Figure 6.5 Completed welded splice retrofit showing filler plate option to close gap.

is recommended so that the load-induced fatigue life of the detail is not reduced by the addition of the splice filler plate. In addition, oversizing the welds where possible and adding weld to the transverse and longitudinal sides will help to prevent any possible fatigue development at the weld root. Figure 6.5 demonstrates a welded splice retrofit that includes a filler plate to close the gap between the flange and the transverse stiffener.

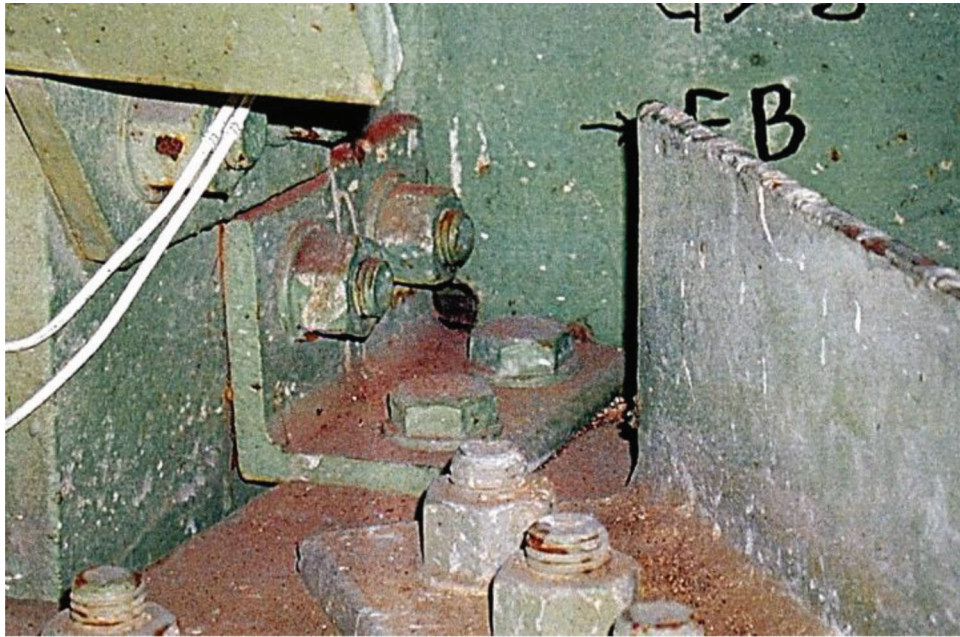
Figure 6.6 Insufficiently stiff splice angle shown installed on gusset-connection plate web gap.

When properly designed and installed, a bolted splice retrofit can be very effective in minimizing distortion stresses in the web gap region. However, when the stiffening elements are not sufficiently rigid, the retrofit will be ineffective. An example of this, shown in Figure 6.6, was investigated by Connor and Fisher (2006). The angle was a 3x3x3/8 angle attached with two bolts per leg and was not capable of providing enough rigidity between the gusset plate and transverse connection plate to prevent the high web gap cyclic stresses. Conceptually this can be seen when comparing the scale of the stiffening angle to that of the adjacent lateral bracing element and floorbeam connection. Not only would this not mitigate the distortion fatigue, but likely the stiffening angle would begin to fatigue as well.
